FOREST INDUSTRY SAFETY ALERT

BCFSC # 2011-09-15 Fatality

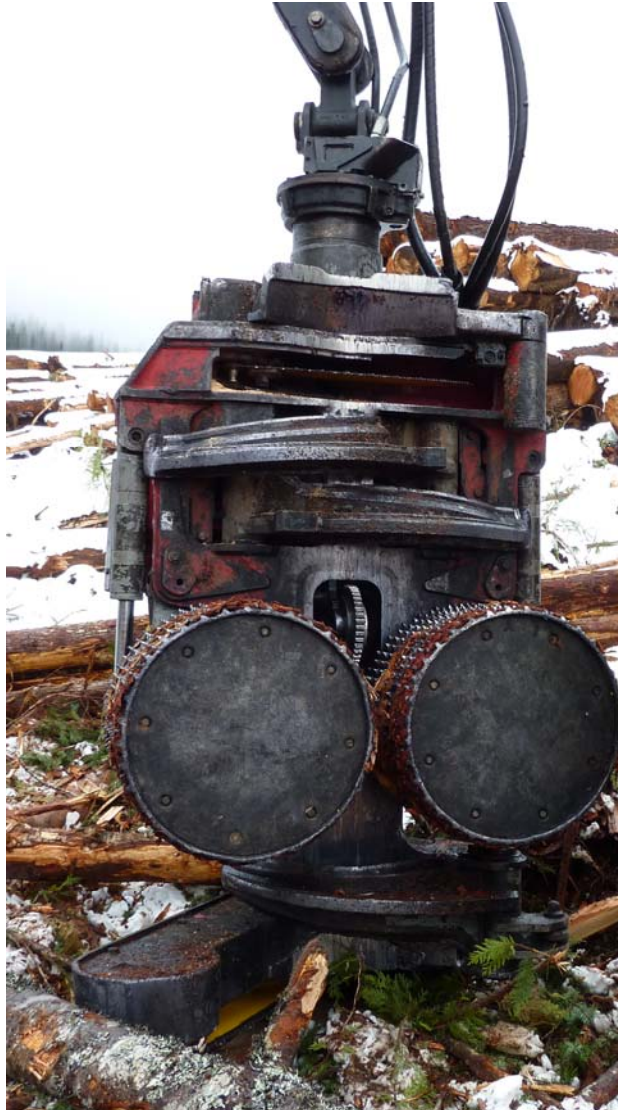
The picture shown above represents one of the various processor heads used in the forest industry and was not connected with the specific incident described above.
