Safety Alert of THE MONTH

October 2010

Hazards and Risk: Steep Slope Operations

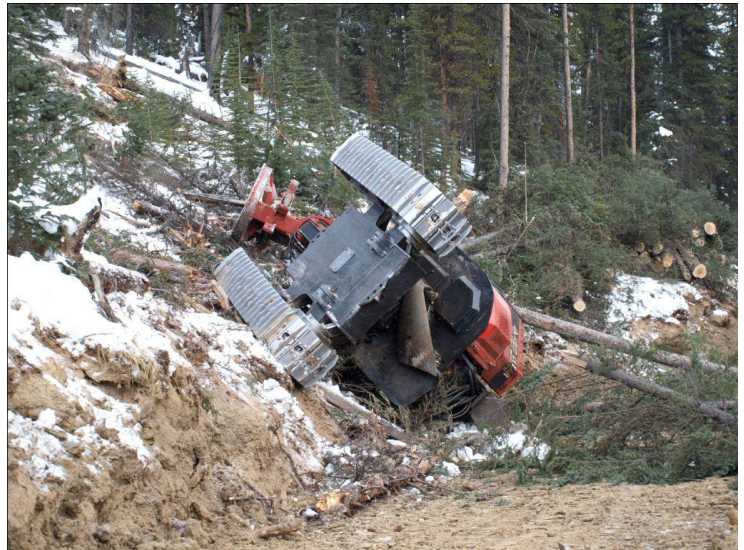
Both alternatives would hold things up so the operator decided to go ahead. Just as he finished cutting one of the trees, the buncher lost traction and started sliding backwards. The machine pivoted sideways to the slope and then toppled over the bank onto the road below, landing on top of the cab. The operator was able to turn the machine off, but the cab had twisted and he couldn't get out of either the main door or the roof hatch. He then tried to remove the front windshield but couldn't pop it either. Efforts to contact the crew on the adjacent block by radio didn't work until he was able to move the antenna into a different position in the cab. Within fifteen minutes, several crew members arrived with extra fire extinguishers, first aid supplies, crow bars, and wrenches. In a short period of time they were able to release him through the front window escape hatch. Other than a few bumps and scrapes, the operator was unharmed. The machine was out of service for a few months and repairs totalled over \$80,000. Lost time and productivity ended up costing the company much more than that amount.

The machine didn't have adequate ice lugs for traction. That's the simple answer; but if you dig a bit deeper you can see how the human factor plays into this. The crew was possibly distracted and rushing due to the impending Christmas break. The operator, the crew's most experienced on steep slopes, had concerns about the slope, but didn't want to slow down the operation. He wanted to do the right thing for the company, but it ultimately turned out wrong. There was the issue that the welder hadn't already been called in to work on the tracks before the operation got into steeper frozen ground.

There also hadn't been an adequate site hazard assessment. The operator didn't realize there was a seep that left an icy patch right under the working surface. Although the operator was following normal safe operating procedures for steep slopes; there was no site-specific risk assessment or working plan that had been developed and agreed to by the supervisor and the operator.
